# Some Consideration of the Teton Dam Failure

Yoshio OHNE and Kunitomo NARITA

### ABSTRACT

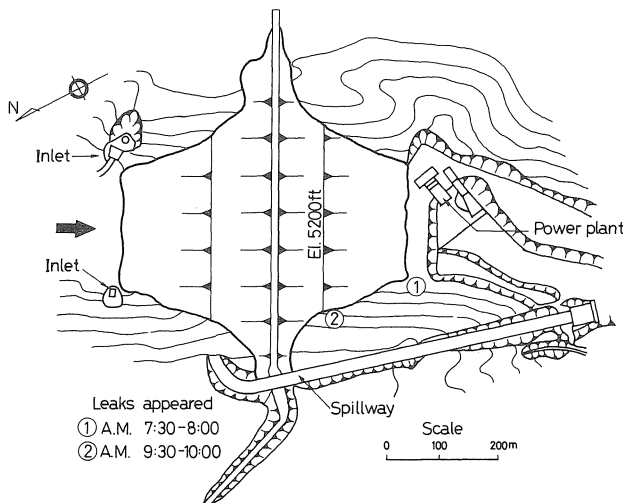
Fig. 1 Plan View of Teton Dam

U. S. B. R.: that is, concentrated leaks through the dam had appeared first in the vicinity of the point at El. 5200ft on the downstream slope between the stations No. 14 and No. 15 (Fig. 1).

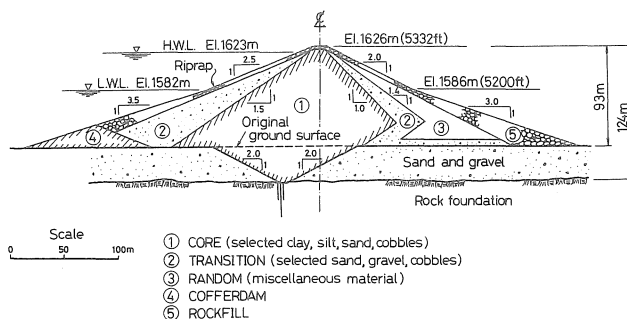
Fig. 2 Cross Section of Teton Dam

Type of fill materials used in the embankment are indicated in Fig. 2. Physical properties and placement conditions of Zone 1 (core) material are summarized in Table-2 and Fig. 4. In Fig. 4, an average gradation of Zone 1 material is compared with grain size distributions of materials which are susceptible to cracking, presented by Sherard et al. (1963). The bottom column in Table-2 exhibits the difference of settlements before and after saturation of materials in oedometer tests. According to

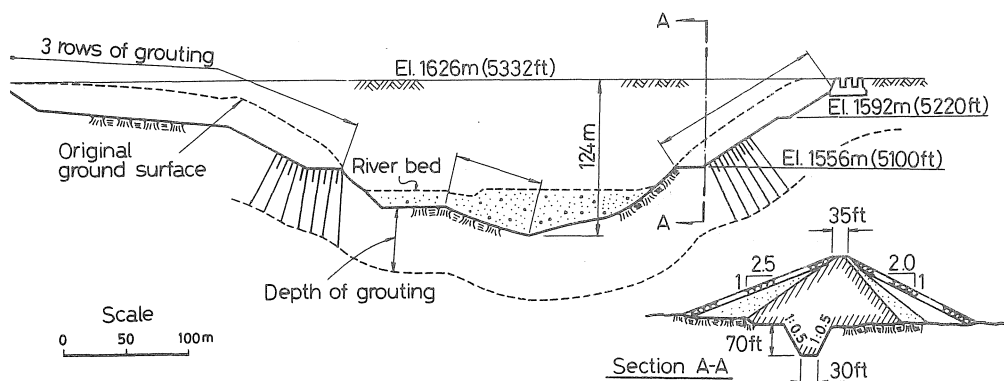
Fig. 3 Longitudinal Section Along the Axis

A longitudinal section along the axis is shown in Fig. 3. The river bed is at about El. 1530m and its width is about 220m. Both abutments consist of steep rock walls extending to El. 1620m, with slopes ranging from 1:1.0 to 1:1.5. Foundation rock is welded, rhyolite ash-flow tuff, which is about 1.9million years old. Inhigher elevations

abutment rock above El. 1556m, as shown in Section A-A in Fig. 3. Below that elevation, a cut-off trench was excavated to foundation bedrock, reaching about 30m in maximum depth. The foundation was grouted below these trenches extending from 60m to 80m in depth. In higher elevations above El. 1556m and in the section between stations 19+90 and 23+90 where foundation rock is highly fractured and jointed, three rows of grouting was needed as shown in Fig. 3, while the grout curtain in other areas consisted of two rows of grout holes.

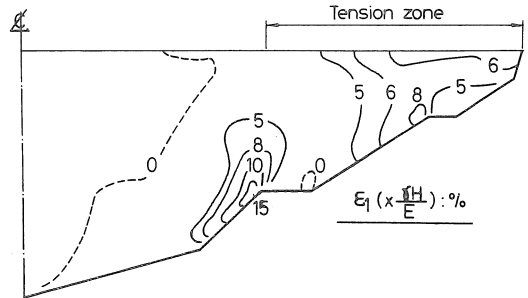
Fig. 7 Contours of Major Principal Strain After Construction

Fig. 7 shows contours of major principal strain  $\epsilon_1$  obtained in the analysis (tension is positive), in which numerical values indicated give actual strains in percents if they are multiplied by the dimensionless quantity  $\gamma H/E$  for the dam under consideration. It is recognized that concentration fields of tensile strain appear not only at the crest of the dam but in the vicinity of both benches, and that the maximum tensile strain developed near the lower bench is about two times as large as others. The extent of the tension zone which is defined by the horizontal stress distribution along the crest is also presented in the figure. It is seen that the tension zone extends up to the point just above the left edge of the lower bench.

and therefore results in  $w/H=0.285\gamma H/E$ . The value of the dimensionless parameter  $\gamma H/E$  is then given as  $1.75 \times 10^{-2}$  by equating  $w/H$  to 0.5% and tensile strains are calculated applying this value to Fig. 7, as indicated in Table-4.

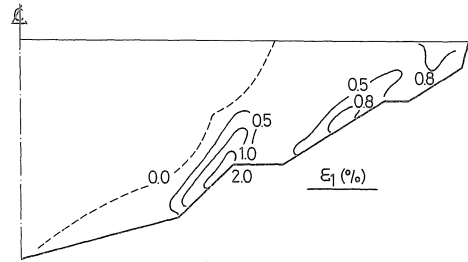
Fig. 8 Contours of Major Principal Strain During Construction

Figs. 8 and 9 show the distributions of internal stress and strain in the state just at the end of construction. In Fig. 8, contours of major principal strain  $\epsilon_1$  show similar concentration fields of tensile strain on the left side of both benches as is indicated in Fig. 7. In the distribution of major and minor principal stresses (Fig. 9), the principal stress ratio  $\sigma_1/\sigma_3$  becomes larger near both benches, resulting in concentration of shear stresses. In the top portion of the embankment, tensile stresses develop in the shaded elements: their stress levels are

For the parts near the two benches, rather severe strain concentration and stress reduction had been experienced due to the differential settlement during construction (Fig. 8). As the dam was completed and the reservoir began to rise in comparatively high speed, settlements developed rapidly due to the saturation of fill materials, reaching about 0.5% on the average. Such post-construction settlements were also accompanied by strain concentration on and around the benches, and the sum total of maximum tensile strains during and after construction may have reached about 1 to 3 percents (Table-4).

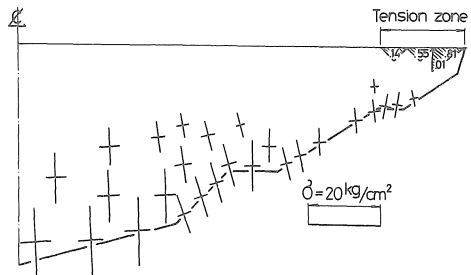
Fig. 9 Distribution of Major and Minor Principal Stresses

represented in  $\text{kg}/\text{cm}^2$ . It is recognized that comparatively large tensile stress develops at the core contact area where the inclination of slope is locally steep due to the proximity to the wall of spillway structure.

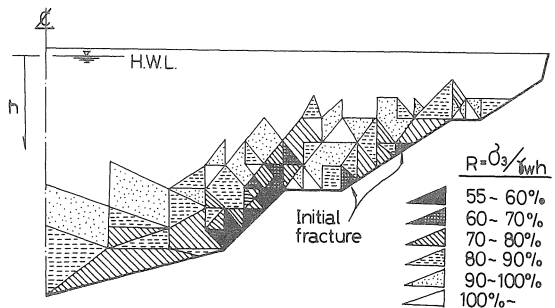
Fig. 10 Distribution of "R"

Fig. 10 shows the distribution of the ratio "R" of minor principal stress  $\sigma_3$  to the hydrostatic pressure  $\gamma\omega h$  at the element under consideration, in which the reservoir is assumed to be fully impounded. The ratio R is expressed in percentage and every element is marked according to the range of R as it exists.

For the purpose of examining the hydraulic fracturing potential at Teton dam, minor principal stress  $\sigma_3$  is compared with the hydrostatic pressure  $\gamma\omega h$  in Fig. 10 for every element within the longitudinal section of the dam. The distribution of R indicates the most dangerous region along the slope on the left side of the lower bench, showing 50% to 70% of R over considerably wide extent. It also shows lower values of R extending over the left portion of the upper bench. In such a narrow V-shaped key trench as in Teton

As stated before, fracture does not always occur even when  $\sigma_3$  satisfies the former criterion in Eq. (1). It is well understood, however, that much more severe situation of hydraulic fracturing would come out if  $\sigma_3$  also satisfied Eq. (4) or Eq. (5), because these are essentially equivalent to the criterion for major principal stress. When applying these criteria to the distribution of R in Fig. 10 and examining the fracture process of Teton dam, it can be considered that the hydraulic fracture might have developed first along the abutment slope between the two benches (rather in the vicinity of the lower bench), and have showed progressive upward enlargement to the upper bench. This inference shows comparatively good correspondence to the situation of the Teton dam failure reported by the

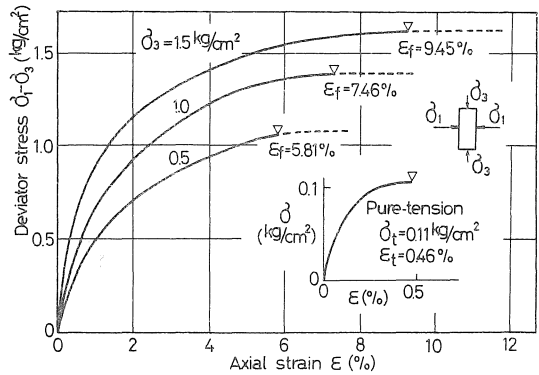
Fig. 11 Triaxial Extension Test (Weathered Mudstone: UU-test)

weathered mudstone material and the Teton Zone 1 material, as shown in Figs. 11 and 12, respectively. The extension characteristics of the weathered mudstone was investigated by giving variety to the confining pressure  $\sigma_3$  and compared with the results of pure-tension test (Fig. 11). In extension tests, the lateral pressure  $\sigma_1$  was increased incrementally up to the failure maintaining the vertical pressure  $\sigma_3$  be constant. The point denoted by a symbol ( $\nabla$ ) on every stress-strain curve signifies the failure state of the specimen where deviator stress reaches maximum value. Beyond this point, the extension strain increases without the increase in deviator stress and the specimen is finally constricted and cut off. The failure strain defined by this critical state shows somewhat constant increase with the increase in applied confining pressure, in the range from 5% to 10%. Note that the cracking strain in pure-tension test on the same sample is 10 to 20 times as small as failure strains in extension tests.

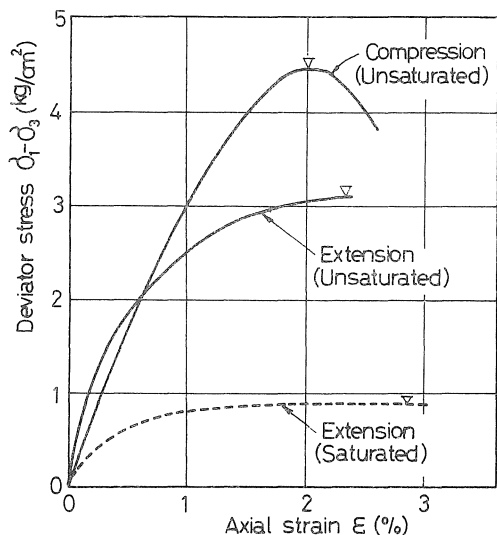
Fig. 12 Core Material of Teton Dam (CD-test,  $\sigma_3 = 0.5 \text{ kg/cm}^2$ )

Fig. 12 shows the results of triaxial extension and compression tests on the Teton Zone 1 material. Drained tests were performed on specimens both in unsaturated and saturated states with a confining pressure  $\sigma_3 = 0.5 \text{ kg/cm}^2$  : the confining

pressure was restricted to this extent for the limit of loading capacity of the apparatus. It is noticed that failure strains are almost the same magnitude both in extension and compression tests, but that the failure strength in extension tests on saturated specimen decreases to be around one-third of that on unsaturated specimen. This suggests that the examination of the cracking potential not only from a strain condition but from a stress condition would be required for areas under a state of compressive stresses.
