# Some Consideration of the Teton Dam Failure

Yoshio OHNE and Kunitomo NARITA

### ABSTRACT

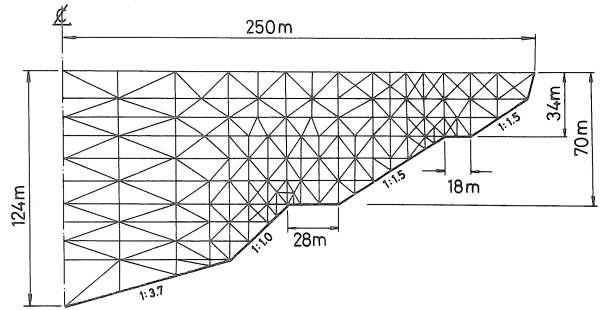
Fig. 6 Finite Element Idealization of Teton Dam Embankment

The profile of the dam was divided into triangular finite elements, as shown in Fig. 6. In this case, only the right section of the embankment in which the breach had occurred was given attention and idealized as a half of a

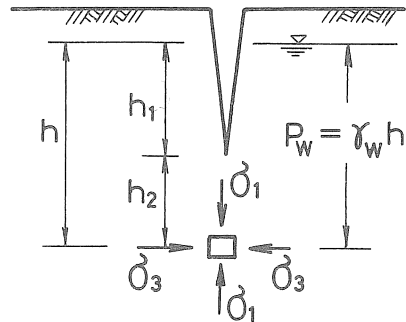
Fig.13 Stress State

in which  $K_0$  is the coefficient of earth pressure at rest, and  $P_w$  is the hydrostatic pressure (Fig. 13). Major and minor principal stresses denoted by  $\sigma_1$  and  $\sigma_3$  in Eq. (1) are those containing the effects of transverse arching, and these are related individually to  $\sigma_1$  and  $\sigma_3$  obtained in the present computation as
